NASA Contractor Report 178246

Test Results for Composite Specimens and Elements Containing Joints and Cutouts

**Douglas Aircraft Company
McDonnell Douglas Corporation
Long Beach, CA 90846**

August 1988

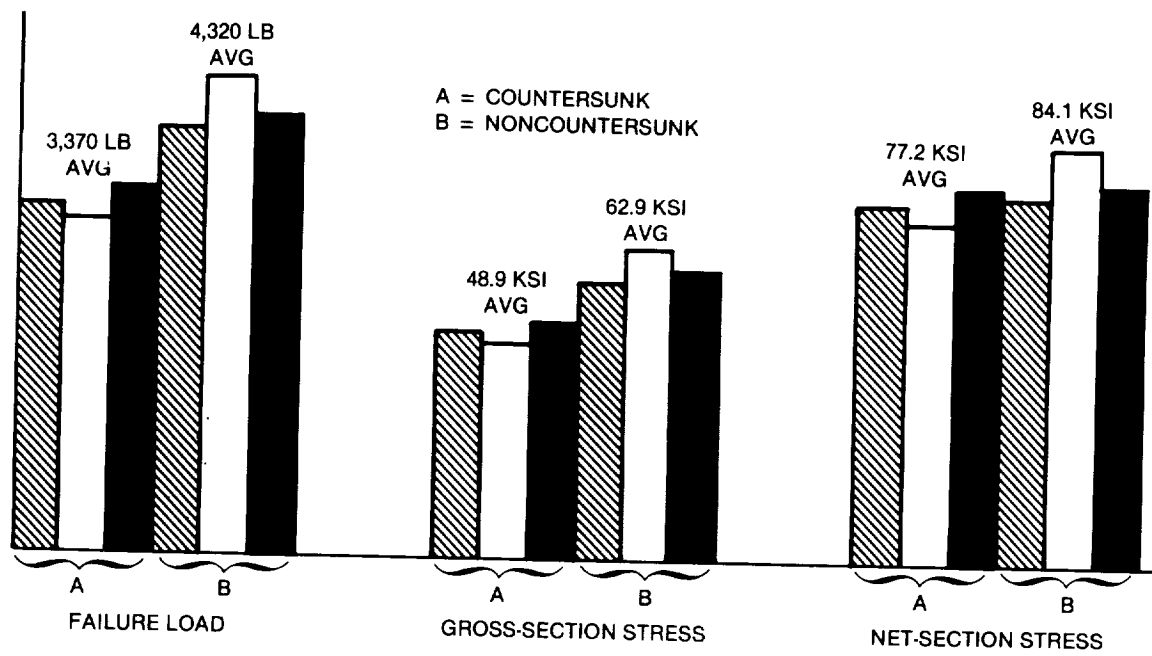
Figure 5-12. Unloaded-Hole Tension Specimen Results (Lay-Up No. 2, Countersunk)

The results of the ULT-507 configuration tests are presented in Figure 5-12. Comparisons are shown between this configuration and its noncountersunk counterpart (ULT-503). As indicated, failure load and gross-section stress are down by an average of 22 percent. Net-section stress, however, shows considerably less reduction (only 8 percent).

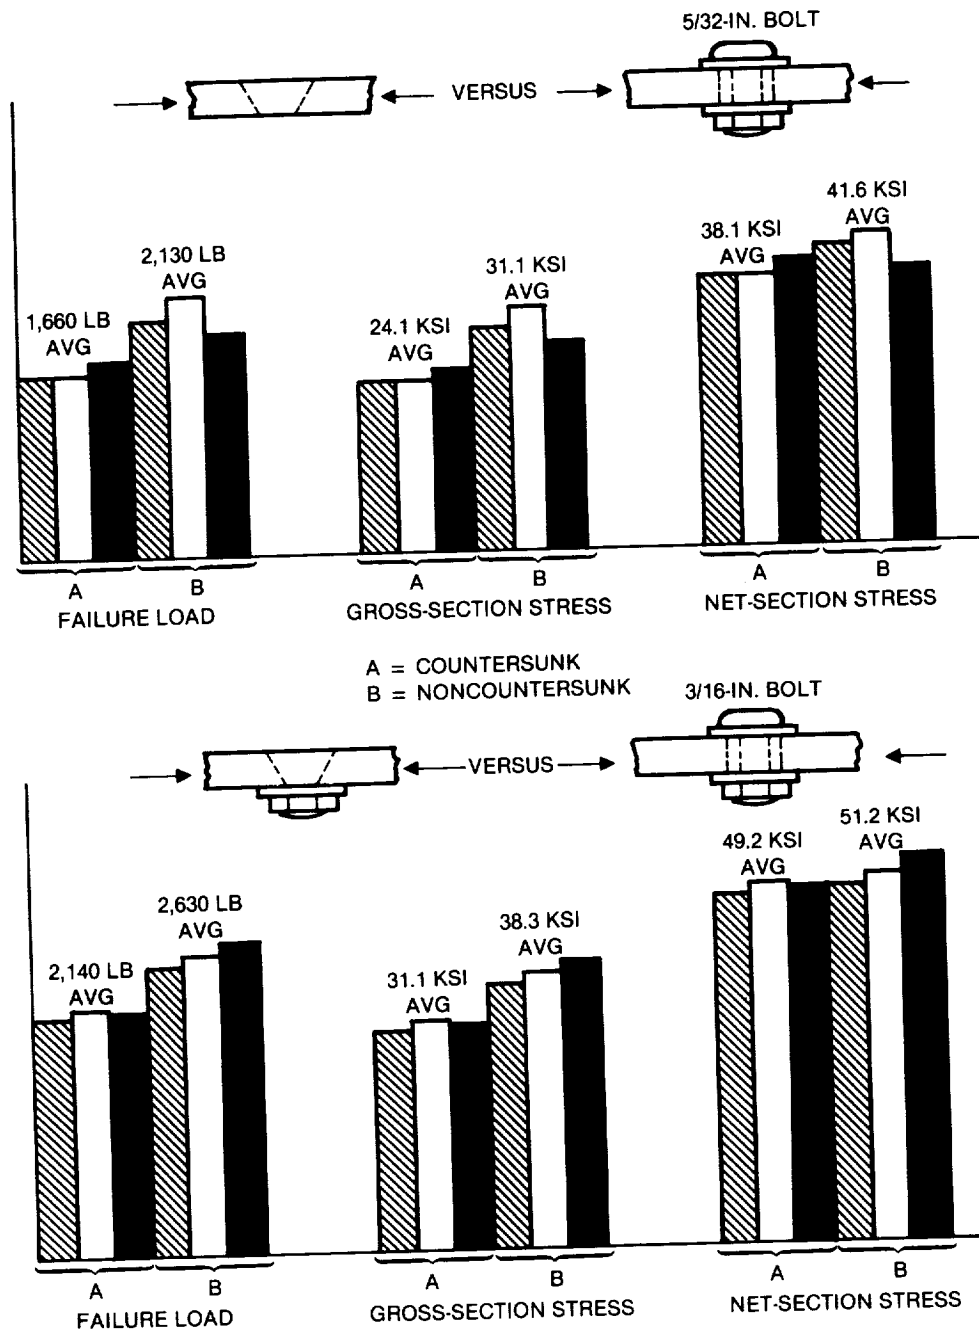
Figure 5-13. ULC Specimen Test Results (Lay-Up No. 2, Countersunk)

The results of the countersunk ULC tests are presented in Figure 5-13. The -515 and -521 ULC specimens were tested with 5/32-inch and 3/16-inch protruding head fasteners to simulate loose fit and net fit bolts, respectively. The -525 configuration was tested *without* a fastener and the -527 configuration with a 3/16-inch countersunk bolt to simulate the same situations for countersunk fasteners. Comparisons of the failure loads of the -525 and -515 configurations again reveal an average drop of about 22 percent. Likewise, net-section stress comparisons show a much smaller drop: about 9 percent. Similar comparisons for the -527 and -521 configurations indicate the countersinks have less effect for the net fit case, demonstrating drops of 19 percent and 4 percent, respectively, for the average gross-section and net-section strengths. Figures 5-14 and 5-15 show typical failures for the two countersunk ULC configurations.

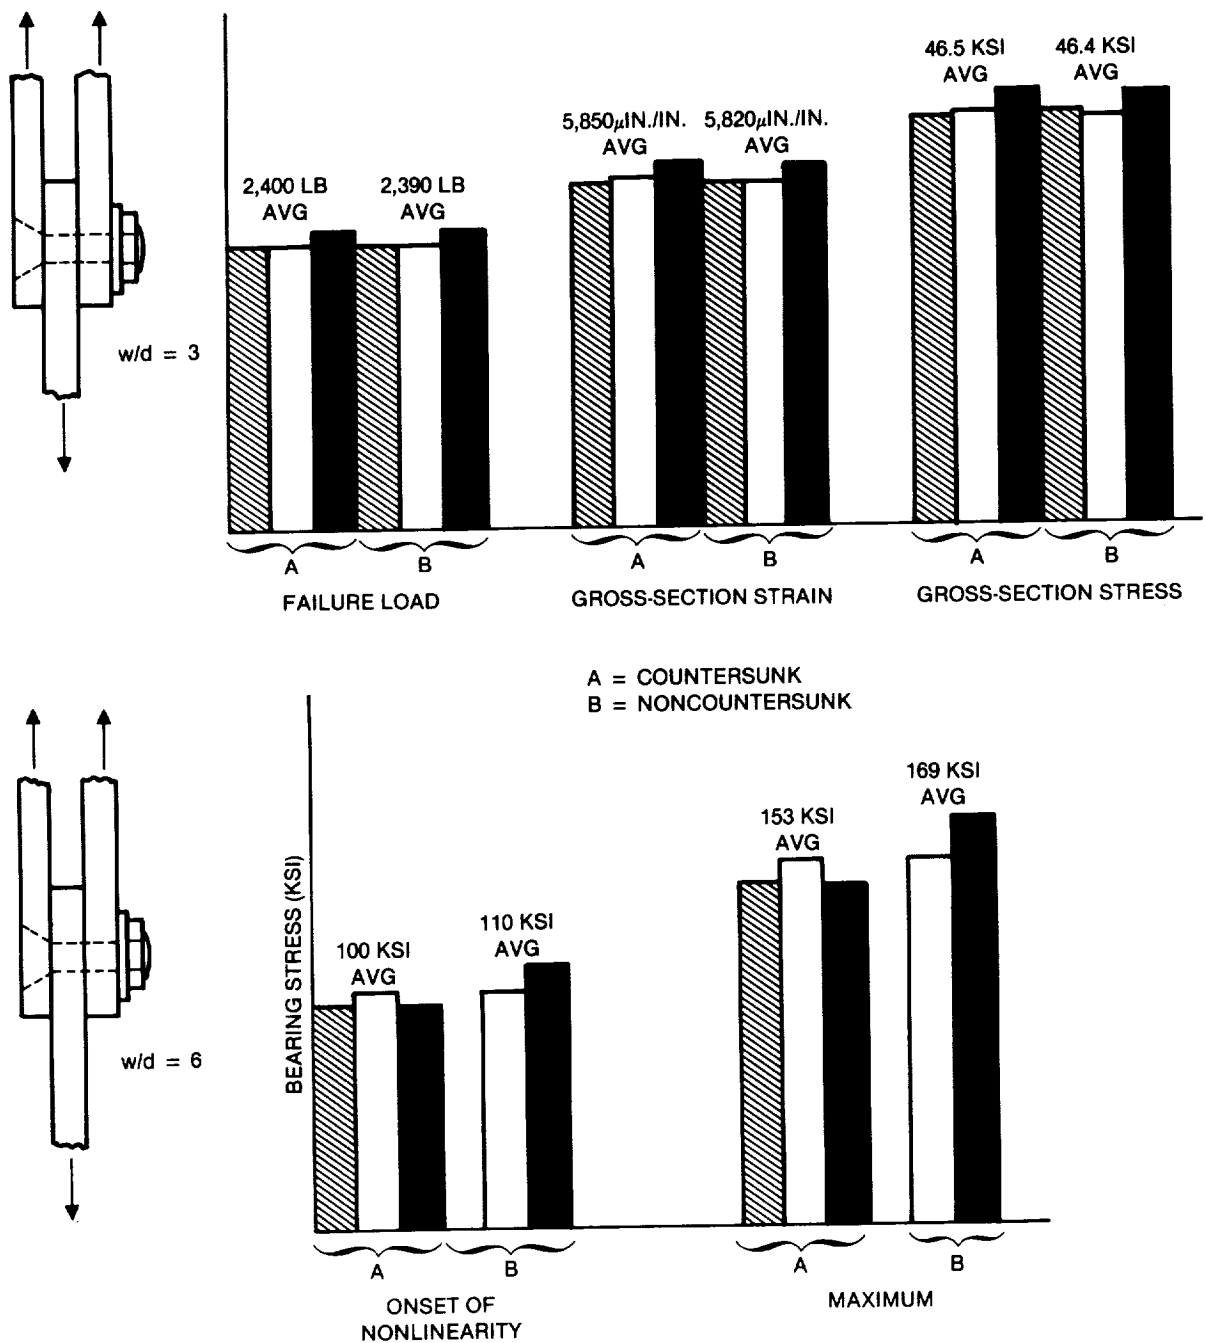
Figure 5-16. DLT Specimen Test Results (Lay-Up No. 2, Countersunk Fastener)

All of the DLT and DLC specimens failures occurred in the center member rather than in either of the splice plates. Therefore, the effect of using countersunk fasteners would be expected to be minimal. Figure 5-16 gives a comparison of countersunk and noncountersunk test results for both the narrow and wide DLT specimens. As can be seen, virtually no change in strength was evidenced for the narrow specimens (which failed in net-section tension). Bearing strengths on the other hand (from the wide DLT specimens), demonstrated a reduction of about 12 percent when countersunk fasteners were used. Figure 5-17 presents a similar comparison for the DLC specimens.

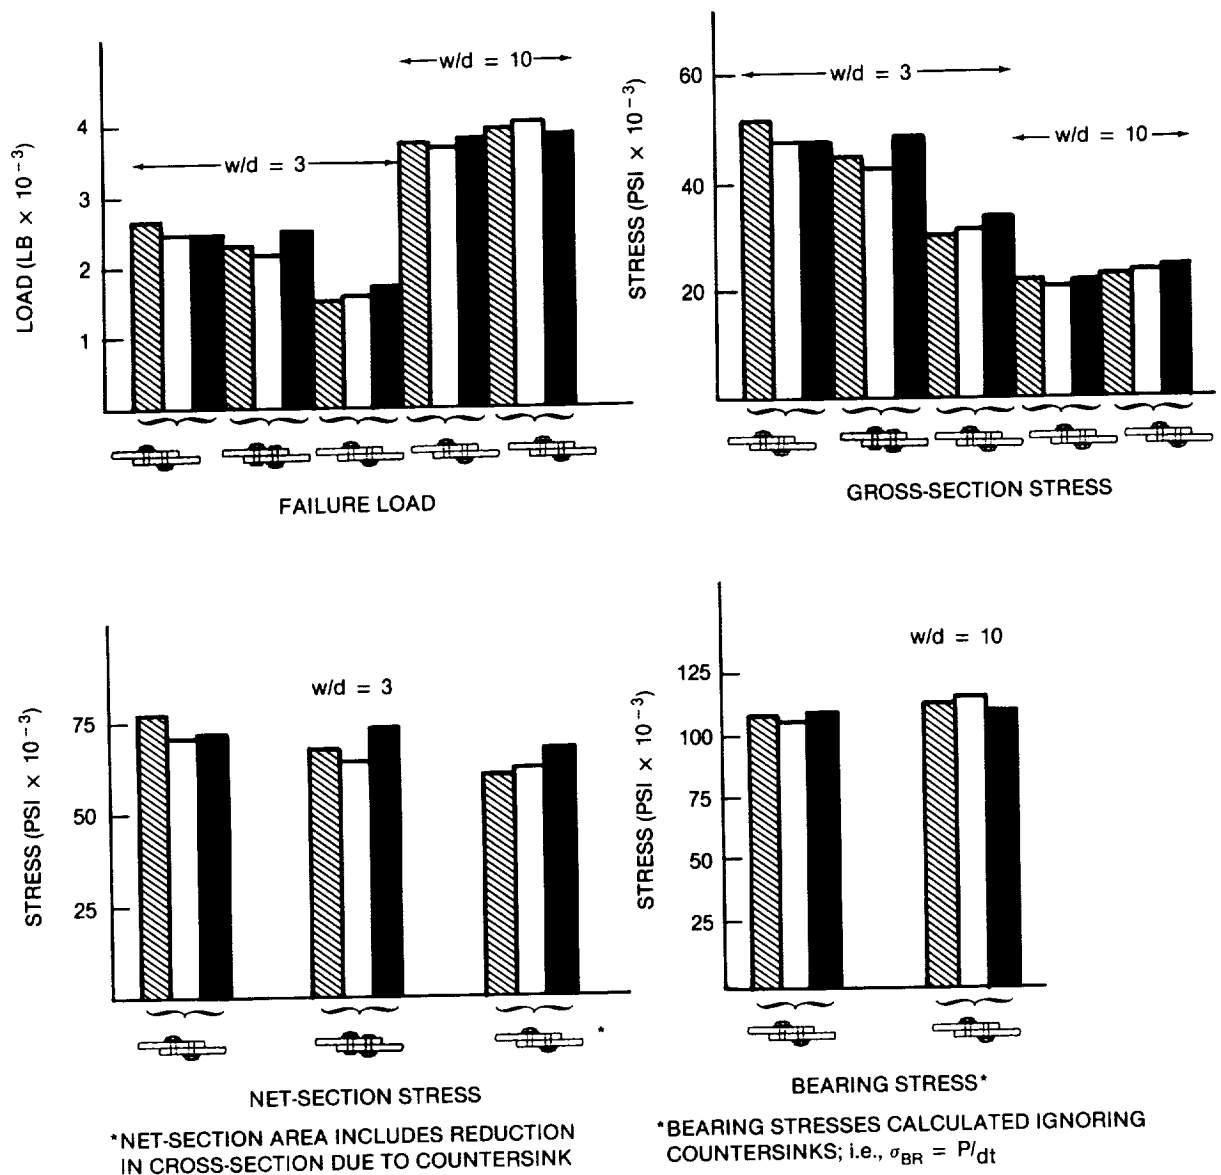
Figure 5-18. SLT Specimen Test Results

The single-lap tension specimens (SLT) were designed to provide coupon level data for single shear joints. Figure 5-18 summarizes the SLT test results. All of the narrow specimens failed in net-section tension at one of the "bearing + bypass" locations. In the case of the -507 configuration, the net-section stresses shown account for the area removed by the countersink. (This was the only configuration that was countersunk at the failure location.)

other, (-507) was through a countersink. Comparison of the -501 and -505 data suggests the countersunk configuration is actually stronger than the noncountersunk configuration (again, as long as the critical "bearing + bypass" location is not in a countersunk member). This is thought to be a result of the reduced eccentricity of the countersunk connection. The test results of the -503 and -509 (wide) SLT configurations were very similar. These specimens failed as a combination of the fasteners pulling through the laminate and failure of the fastener heads. Considerable fastener rotation and hole deformation was also evident. Although the failures were not pure bearing failures (like those seen for the wide DLT and DLC specimens), Figure 5-18 includes nominal bearing stresses (ignoring the countersinks) for reference and comparison. Load/deflection properties were also recorded for the -501, -503, and -505 configurations.

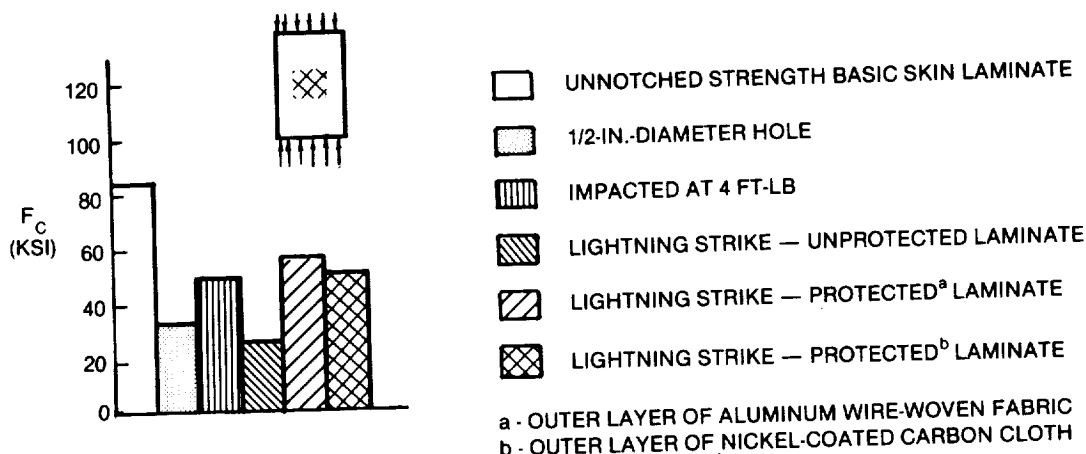
Figure 5-20. CAI Specimen Test Results

The last of the Group A specimens were the compression-after-impact or CAI panels. The results of these tests are summarized in Figure 5-20. The highest strength loss observed was for the unprotected panel subjected to lightning strike, followed by the panel with a 1/2-inch-diameter hole. However, the impacted panel and the protected panels subjected to lightning strike all exhibited strengths greater than 39 ksi (the stress corresponding to the design ultimate strain of $4,500 \mu\text{in./in.}$).

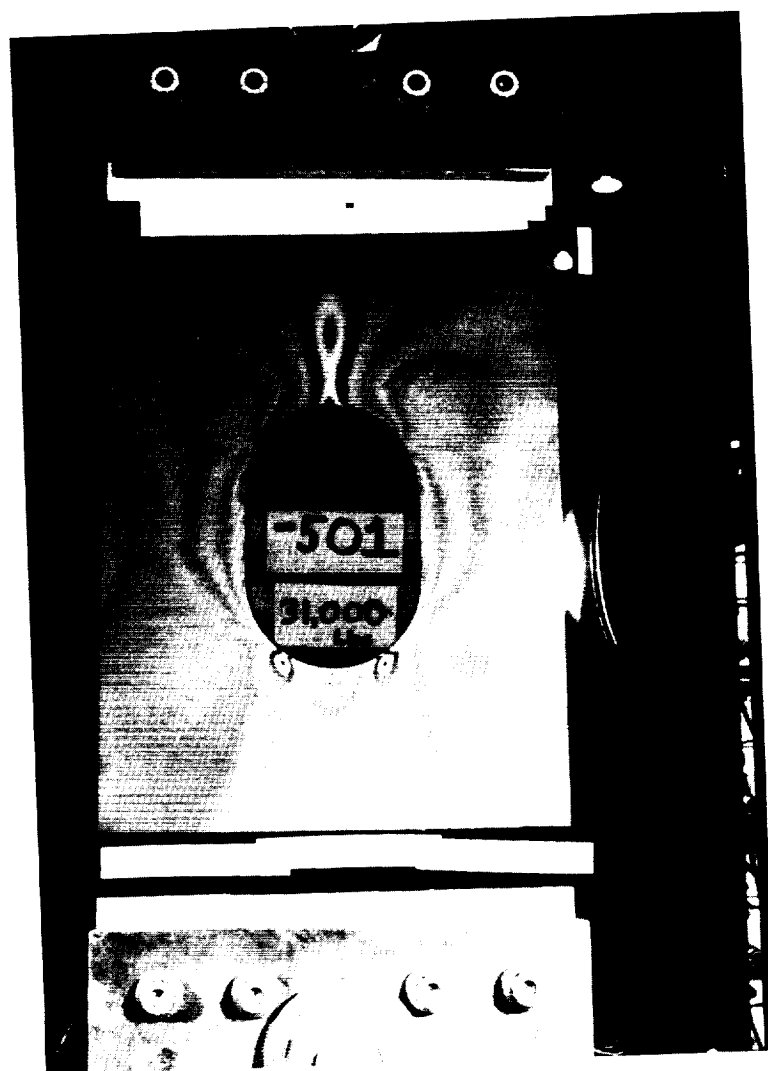
Figure 5-22. Photoelastic Fringe Pattern for -501 Tension Cutout Panel

The baseline panel (-501) was the only one to buckle in opposite directions at the top and the bottom of the cutout. This is illustrated in Figure 5-22 by the asymmetry of the photoelastic fringe pattern at 31 kips. Although difficult to discern, the top of the cutout buckled toward the camera, producing tensile strains on the surface being viewed, which subtract from the membrane compressive strains to produce a black, or zero-principal-strain, region. Likewise, the buckle at the bottom of the cutout is away from the camera, producing bending strains which add to the compressive membrane strains. Typical plots of strain gage and photoelastic data are shown in Figures 5-23 and 5-24.

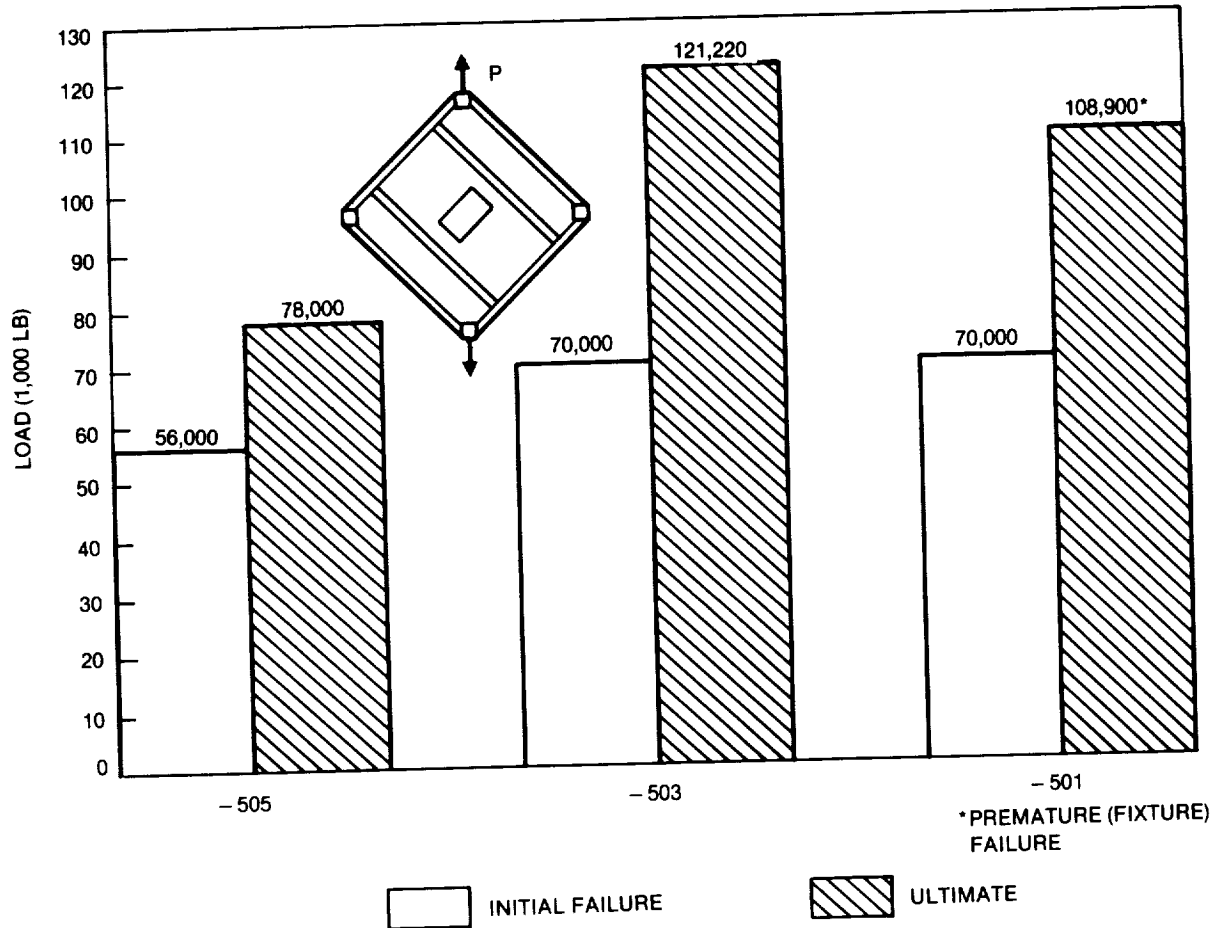
Figure 5-25. Failure Loads for Group B Shear Cutout Panels

A summary of the failure loads for the shear panel tests is given in Figure 5-25. All three panels failed initially at the top and bottom corners of the cutout. These localized failures did not result in the collapse of the panels, however. As indicated, the ultimate failure of the -505 panel was precipitated by a partial failure of the picture frame load introduction fixture. Strain gage data indicated that the panel was close to failure before this occurred.

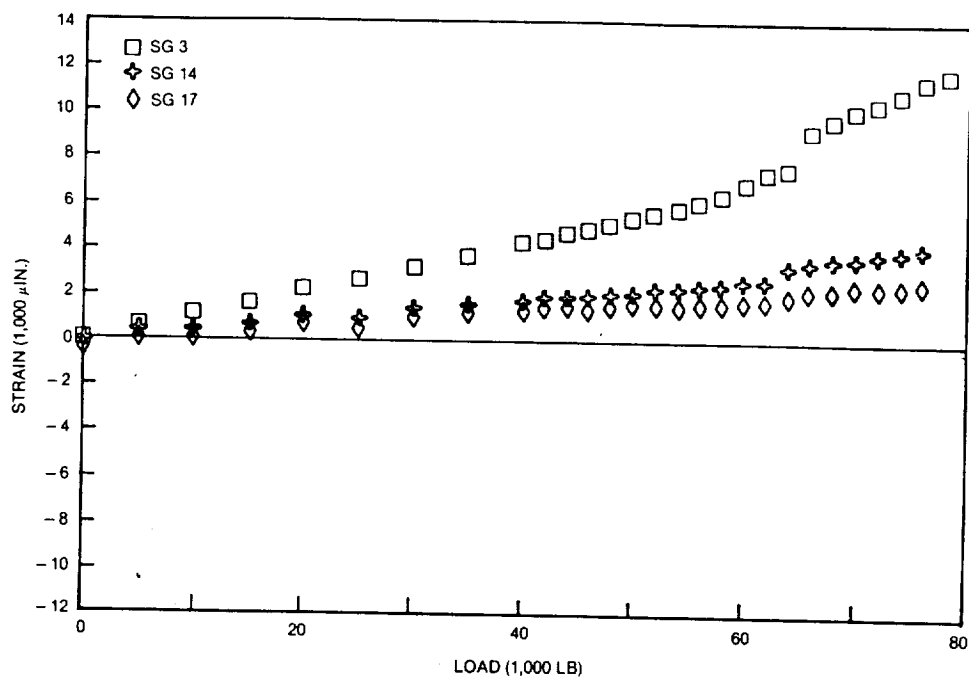
Figure 5-27. Strain Gage Data at Top Corner of Shear Panel Cutout (-501)

A sketch of the failed baseline panel (-501) is included as Figure 5-26. Strain gage data (Figure 5-27) taken at the top corner indicate a moderate change in slope at about 30 kips and a marked nonlinear behavior beginning around 50 kips. While holding the load at 56 kips, a loud noise was heard, and while holding at 58 kips, a drastic drop in measured strain at the top corner ($-9,830$ to $-2,632 \mu\text{in./in.}$) was observed. Inspection of the test article revealed delaminations at the cutout on both compression diagonals (top and bottom corners). As the load was increased, these delaminations were observed to progress toward the intersections of the stiffeners. Panel failure occurred while holding at 78 kips. Ultimate failure appears to have resulted from the stiffeners having disbonded from the panel, thus effectively eliminating the last remaining load path for the diagonal compression load.

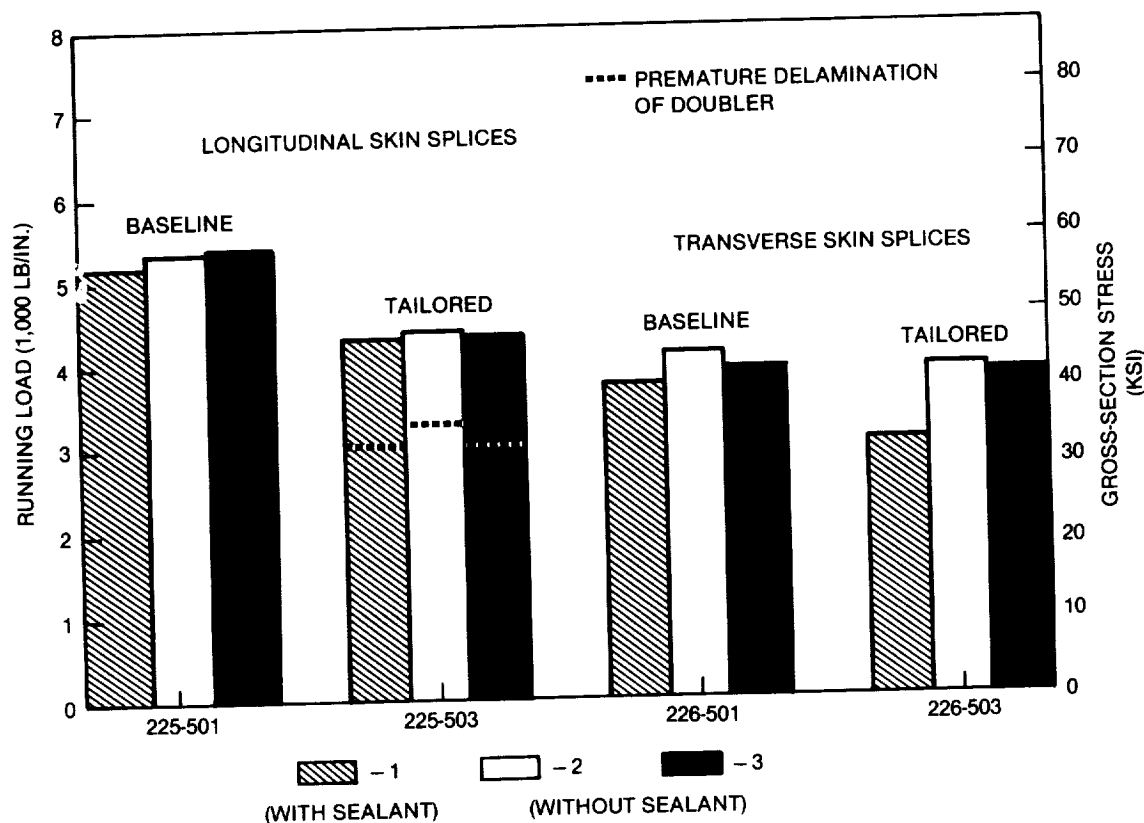
Figure 5-31. Failure Loads for Group C Skin Splice Specimens

The results of the skin splice tests are summarized in Figure 5-31. All of these specimens were fabricated from the basic skin laminate (0.0684 inch nominal thickness) to which four plies of 45 were added at the splice region to yield the reinforced skin laminate (0.0912 inch nominal thickness). Gross-section stresses are based on the built-up thickness. Gross-section strains can be obtained by dividing by measured modulus of elasticity for lay-up No. 2 (7.96 Msi). The first replicate of each of the skin splice configurations was tested with faying surface sealant while the second and third were tested without. The presence of the sealant had little effect on the strength of the longitudinal skin splices. The strengths of the transverse splices were more noticeably affected (reduced) by the presence of the sealant. This reduction is generally attributed to the increased eccentricity of these single-shear joints due to the added thickness of the sealant.

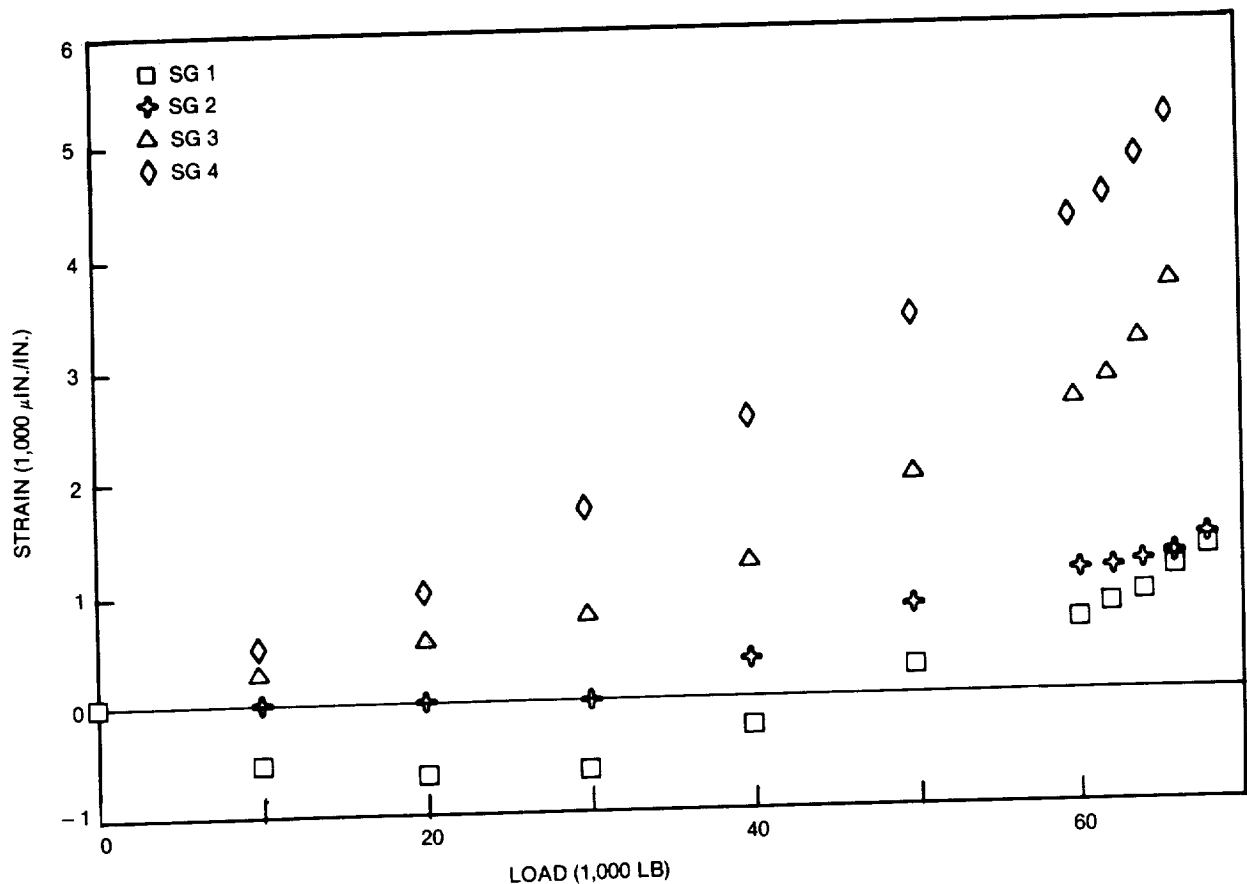
Figure 5-36. Transverse Skin/Longeron Splice Typical Strain Gage Data (Tension)

Strain gage data taken in the vicinity of the splice was noticeably nonlinear. This geometric nonlinear behavior (a result of the eccentricity of the single-shear skin splice) is especially notable in the data from strain gage No. 1 (Figure 5-36). This gage, located in the center of the skin-splice plate, initially read negative even though the applied load was tension. The strain readings leveled off quickly, however, and eventually became positive at about 45 kips. Considerable local bending of the skin and skin-splice members was also visually confirmed during the test. Although not visually detectable, the strain gage data also indicated a degree of eccentricity in the longeron splice, with the strains generally higher in the L-member than in the Z.

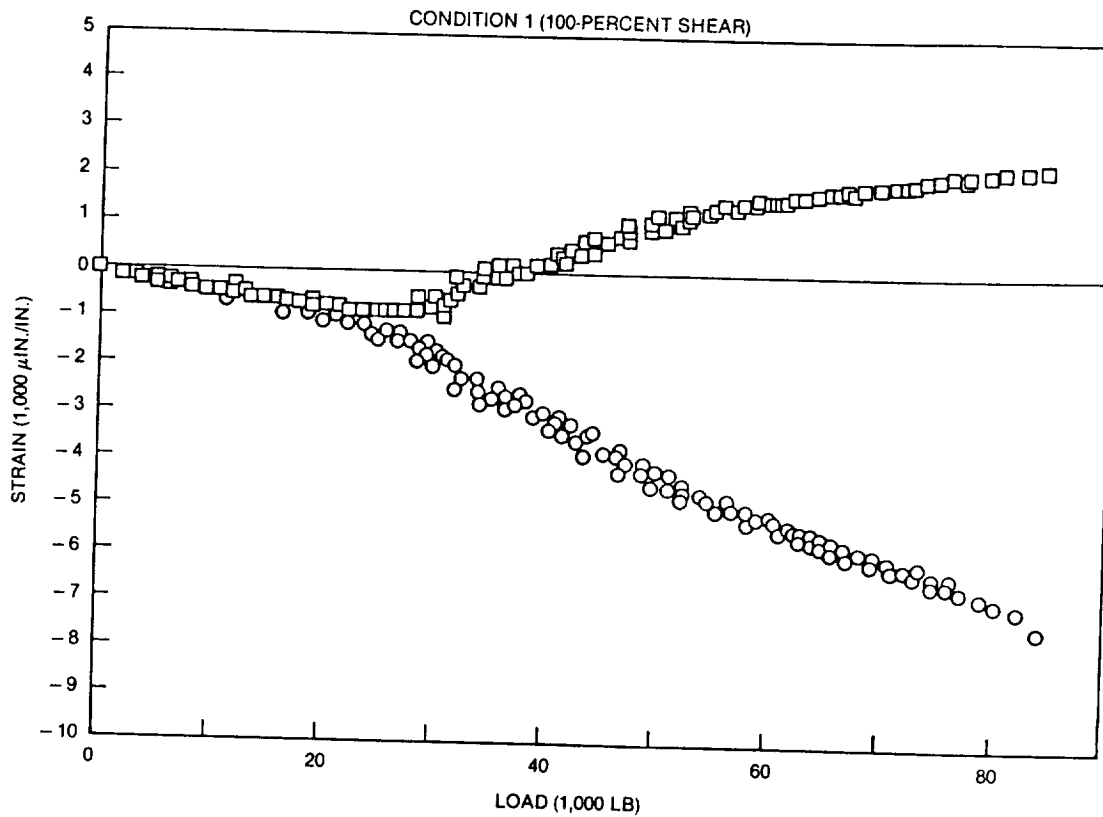
Figure 5-45. Postbuckling Response of Transverse Skin Splice Panel (Shear)

Strain gage data for this specimen (see Figure 5-36) provided information concerning skin buckling and the behavior of the transverse splice. The continuously read data for the shear-only conditions (discussed above) are presented in Figure 5-45. The data and the failure load of 84.1 kips suggest a post-buckling ratio for this panel of between 2.5 and 3.0 (depending on the choice for the initial buckling load). Strain gage data from the small skin bay just above the splice (strain gages No. 5 and 6) indicate a small amount of curvature, which suggests a very shallow buckle present here also. (Skin thickness in this bay was nominally 0.0912 in.). Strain gages at the joint indicated behavior similar to that of the two-stiffener transverse splice panel loaded in compression (i.e., nearly equal strains in the Z and L splice members, and tensile strains on the inside surface of the skin splice plate). The strains at the joint were generally quite low due primarily to the fact that the highest compression load applied was 75 kips, corresponding to a running load of about 1,800 lb/in. (this to be contrasted with the failure load of the two-stiffener panel of 3,336 lb/in.).

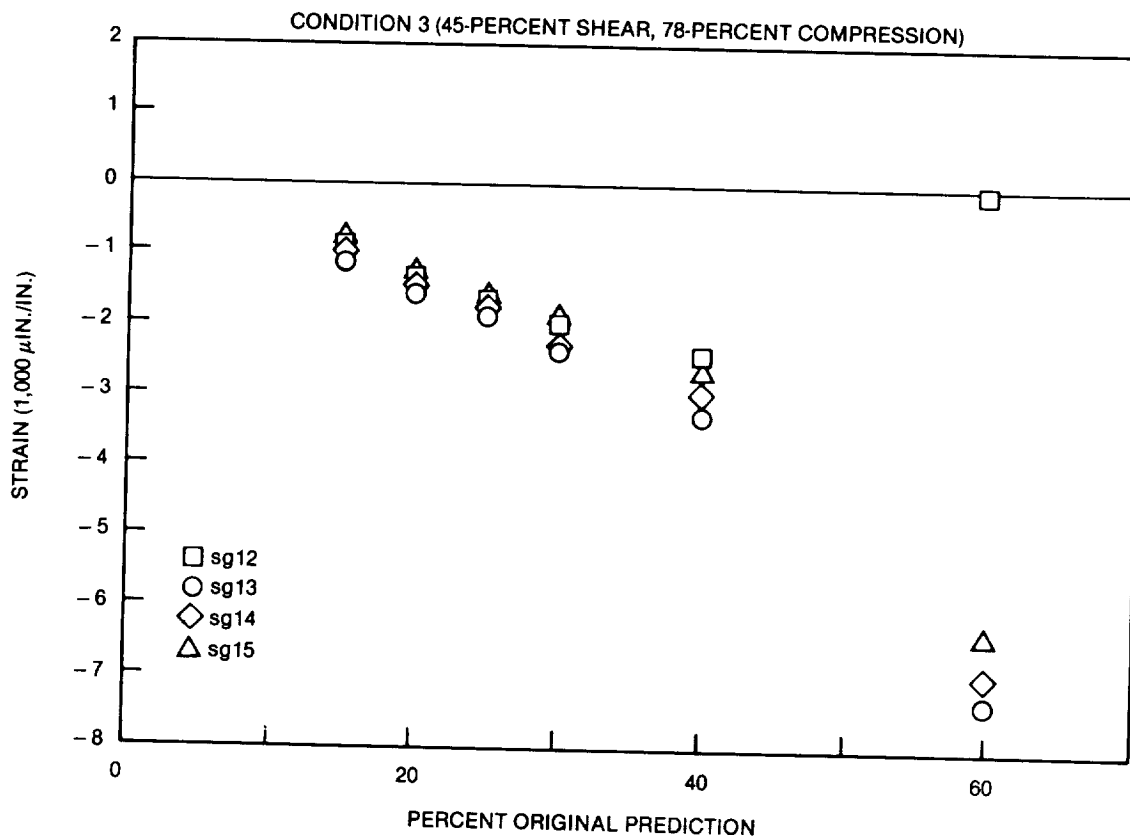
Figure 5-51. Selected Strain Gage Readings for Window Belt Panel

The strains recorded by the gages above and below the cutout remained relatively linear, and were (expectedly) higher for the shear dominated load cases. Those recorded by the gages along the left and right edges were likewise highest for the compression-dominated conditions. There was a noticeable nonlinearity in these data, indicative of either a redistribution of load in the panel, or bending along the cutout. The data from strain gages No. 12 through 15 are the most interesting. The gages located at the lower right-hand corner of the lower cutout (see Figure 5-46) showed the presence of high-compression loads for the shear-dominated conditions. Significant bending was indicated at this location by the difference in the readings from the back-to-back strain gages. These readings were also the most obviously nonlinear. The most dramatic example of this behavior is evidenced in the plot for these gages for Condition 3 (included here as Figure 5-51). It would appear from the severity of the bending indicated at this condition for the 60-percent load series, that a failure at or close to this area had already occurred. However, there was no damage to the skin in this region.

Strain gages at the upper right-hand corner of the lower cutout in Figure 5-46 also displayed a nonlinear characteristic with a moderate amount of bending. These strains were tensile for the shear-dominated conditions and compressive for the compression-dominated conditions. Although a skin failure is indicated at these gages in Figure 5-50 (the upper left corner of the lower cutout), the measured strains were quite low just prior to the collapse of the panel. This adds credence to the observation made from the videotapes that this side of the panel was not involved in the initial failure.
